RECONDITIONING A ROOTS 1024 RGS-HVB VACUUM BOOSTER

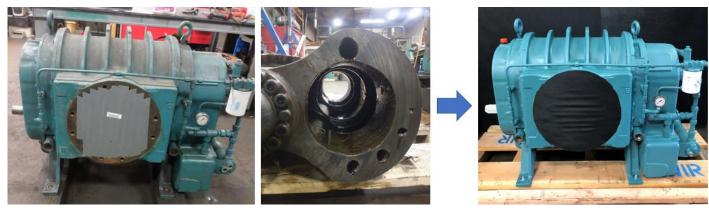
BEFORE

AFTER

- Base repair quote supplied to customer prior to receiving the equipment
- Complete visual inspection and disassembly of booster and components
 - > Contact on drive end rotors and endplate

- Drive end endplate cracked
- Pictures of tear down taken and included in firm quote with detailed description of required repairs
- > Firm quote submitted to customer for approval prior to continuance of work

- Complete mechanical and chemical cleaning of all internal components and external surfaces
 - Grind rotor ends, match length
 - Grind housing length to re-establish clearances

- Balance rotors
 - > Clean heat exchanger, replace gaskets and pressure test
 - > Installation of new mechanical seals, bearings, gaskets, O-rings and keys

- > Replace mechanical seal leak sight glasses
 - Replace endplate
- Set internal clearances to factory specs
- Replace oil filter and pressure gauge
- > 60-minute test run of complete assembly with data acquisition program

- After break-in period has been met, system is helium leak-checked
- Copy of test data acquisition pump down curve included in shipping documents
- Prep, paint and palletize for shipment
