RECONDITIONING A TUTHILL 9016 PD PLUS BLOWER

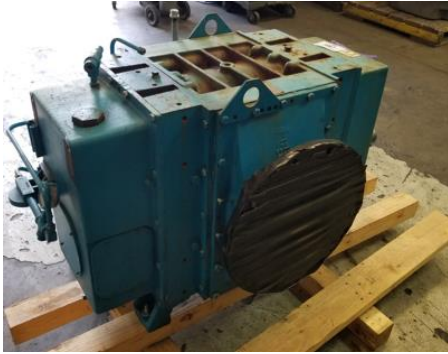
BEFORE

- Base repair quote supplied to customer prior to receiving the equipment
- Complete visual inspection and disassembly of blower and components
 - Drive shaft seal journal worn
- Pictures of tear down taken and included in firm quote with detailed description of required repairs
- Firm quote submitted to customer for approval prior to continuance of work
- Complete mechanical and chemical cleaning of all internal components and external surfaces
 - Balance rotors
 - Ceramic coat drive shaft seal journal
 - Installation of new mechanical seals, bearings, gaskets and O-rings
 - Replace piston ring assembly
 - Replace oil sight glasses
 - Replace oil filter
- Set internal clearances to factory specs
- 60-minute test run of complete assembly
- Prep, paint and palletize for shipment
