RECONDITIONING A BUSCH 250-132 ROTARY VANE PUMP

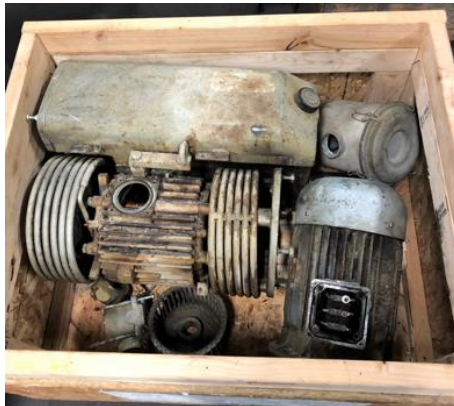
BEFORE

- Varnish build up on internals
 - Seal journals worn
 - Motor test failed
- Pictures of tear down taken and included in firm quote with detailed description of required repairs
