RECONDITIONING A RIETSCHLE VWZ-252 2-STAGE ROTARY VANE

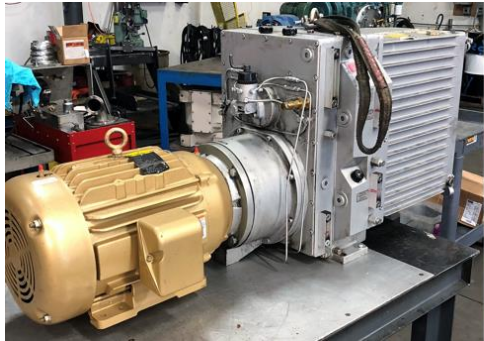
BEFORE

- Base repair quote supplied to customer prior to receiving the equipment
- Complete visual inspection and disassembly of rotary vane and components
 - Gears worn and damaged

- Drive shaft seal worn on LP stage
 - LP stage contact on the drive end
- Pictures of tear down taken and included in firm quote with detailed description of required repairs
